Local Law 11 Report

Local Law 11 of 1998 - Fifth Cycle

Critical Examination of Exterior Walls and Appurtenances (Section 27-129 of the New York City Building Code)

The St. Regis Hotel

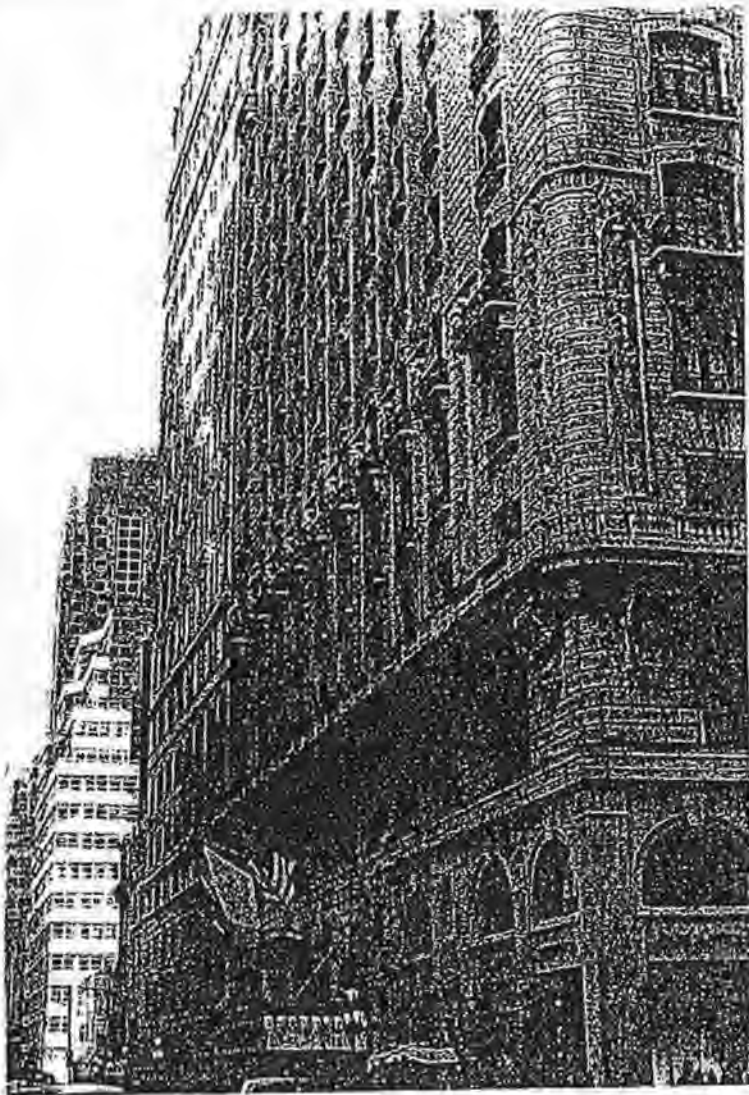
Photo #
1

East 55th St elevation

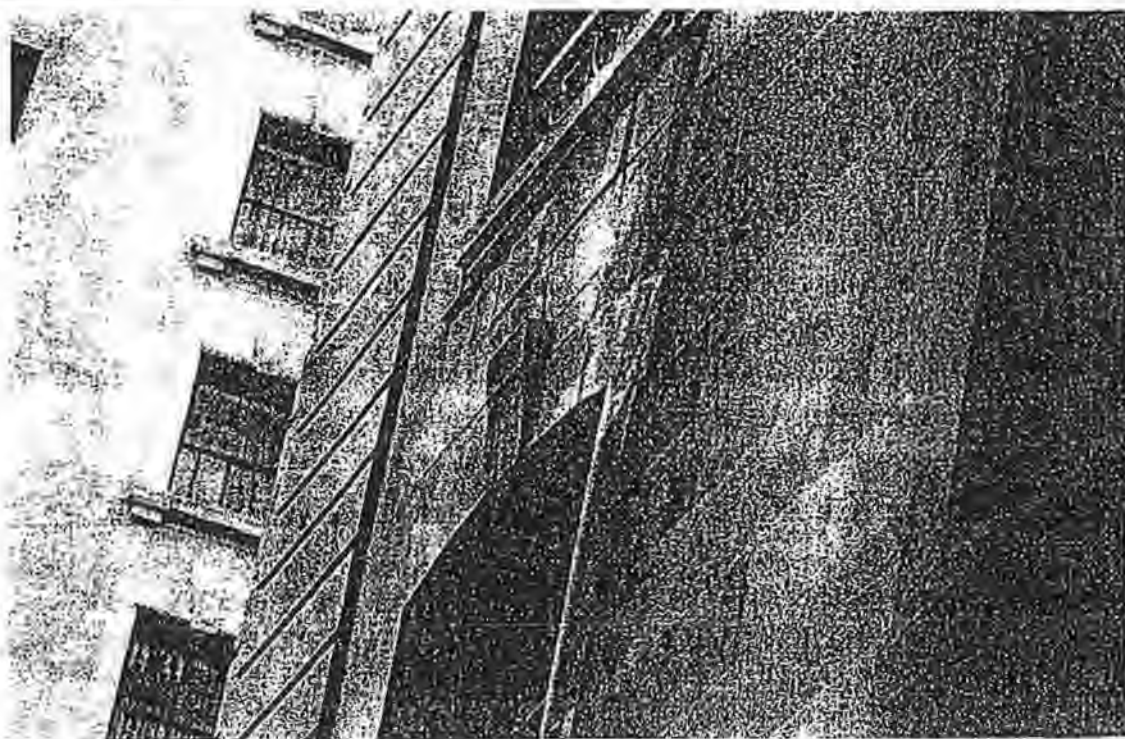
Photo #

5. WINDOW STONE LINTELS AT THE SOUTH FACING FACADE, FLOORS 6 THROUGH 12 HAVE SPALLS OR CRACKS. (SEE PHOTO # 4 AND # 6)
6. THERE ARE ISOLATED STONE SPALLS AT THE NORTHWEST CORNER FROM THE 6TH TO THE 10TH FLOORS.

spalled limestone at window head

- A. ITEM 1 (REPAIR WITHIN THREE MONTHS)
- B. ITEMS 2 AND 3 (REPAIR WITHIN 12 MONTHS)
- C. ITEMS 4 THROUGH 10 (REPAIR WITHIN 18 MONTHS)
